**ROYAL AIRCRAFT ESTABLISHMENT**  
F A R N B O R O U G H , H A N T S

**DEVELOPMENT OF THE  
INDICATOR, ANTI-SUBMARINE,  
TRAINING No.1, Mk.1**

Technical Note No. Arm.534

January, 1954

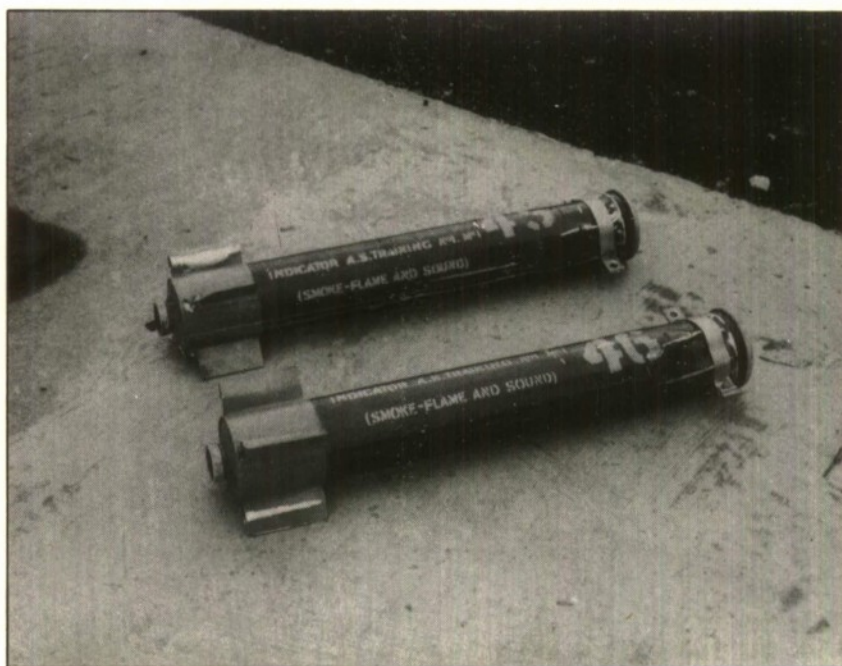
In equipping the float to withstand the high crushing forces imparted by the functioning of the sound unit Fig.2 it was considered that the spruce liner support should be replaced by materials possessing:

1. 24 S.W.G. (.022) M.S. OUTER CASING WITH SPRUCE SUPPORT LINER

FIG.2. INDICATOR, A/S TRAINING No.1, Mk.1  
DAMAGE CAUSED TO PROTOTYPE FLOATS BY SOUND UNIT FUNCTIONING

- (I) Higher radial compressive strength.
- (II) Low and consistent density (for floatation).
- (III) Low Moisture content (to improve the shelf life of the pyrotechnic compositions).

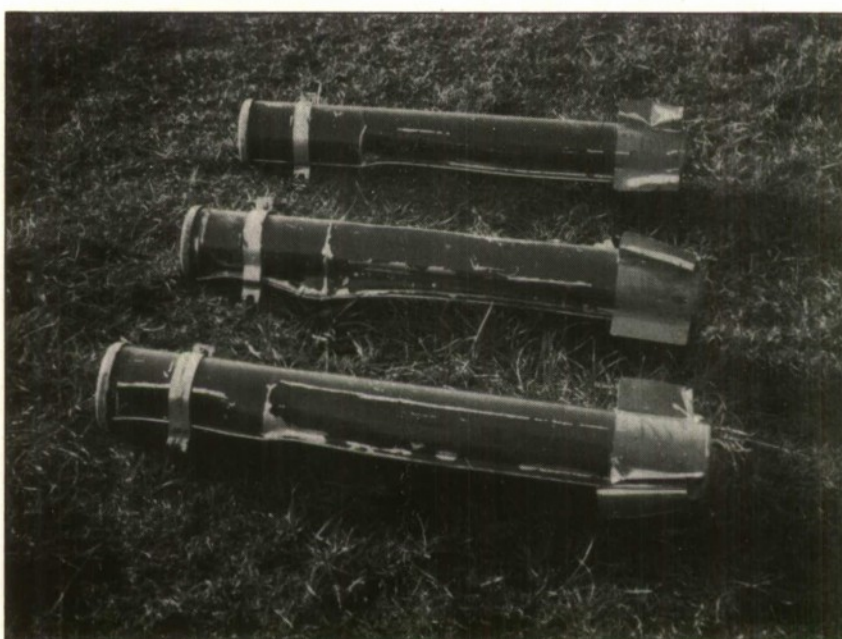
2. 24 S.W.G. (.022) M.S. OUTER CASING LINED WITH SPRUCE AFT AND MAGNESIUM ALLOY SLEEVE CASTING FORWARD

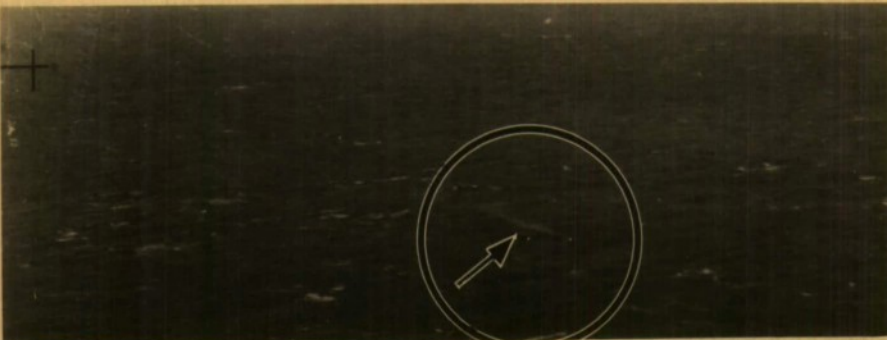
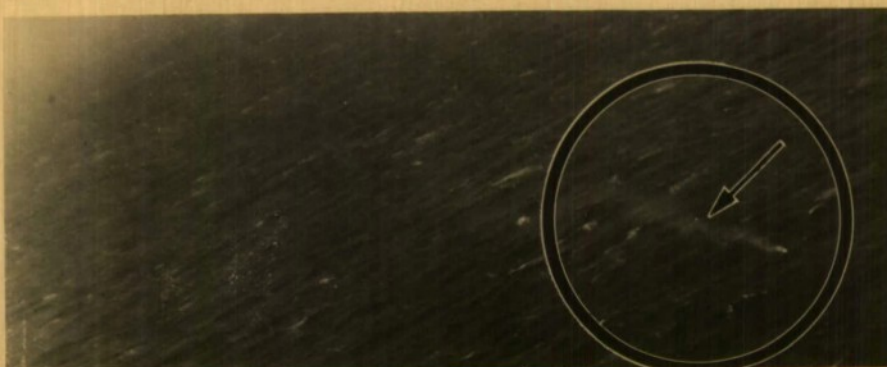
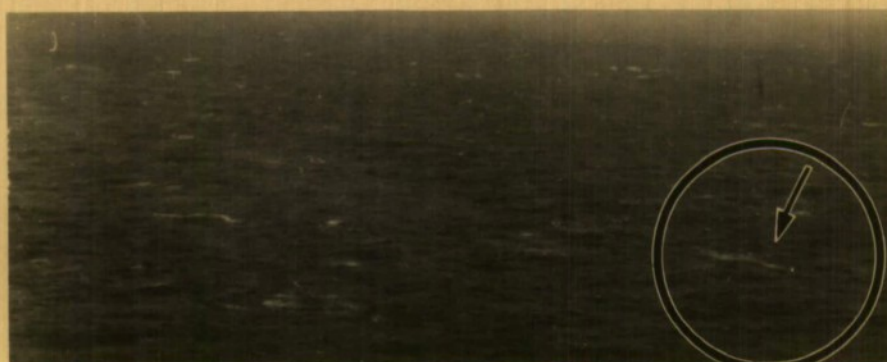
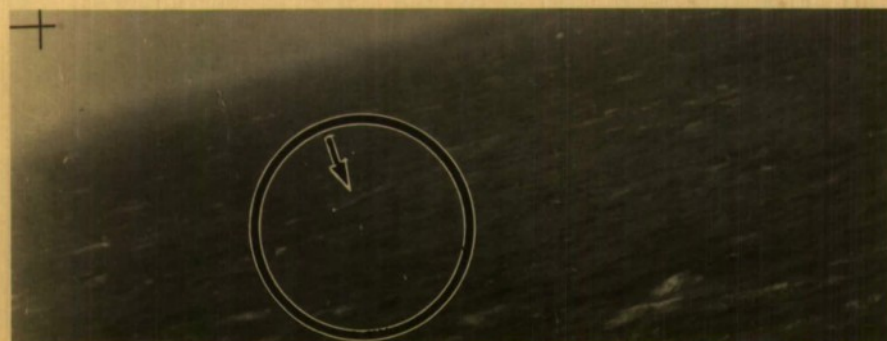
FIG.4. INDICATOR, A/S TRAINING No.1, Mk.1

With emission orifices reduced to 5/32" diameter (Mod.8B) to improve smoke performance in rough seas stores were dropped for comparison alongside Markers Marine 19 lb 20 miles outsea in the English Channel in conditions, sea, state 3-4, wind 30 knots, visibility 1-3 miles. The distraction of many white caps on the sea and difficulty of orbiting the aircraft within the short visibility made it extremely hard to locate the markers (both types) and keep them in sight. Consequently, or because of malfunctioning, the emissions from four of the Indicators were not located.

the eight Indicators which were seen to produce smoke. Air photographs of four of these are given in Fig.4. A photograph taken of a Marker Marine emission with that from an Indicator alongside Fig.4/4 failed to register the former. Visually, the emission from the Indicator was adjudged to be as effective as that produced by the marker.

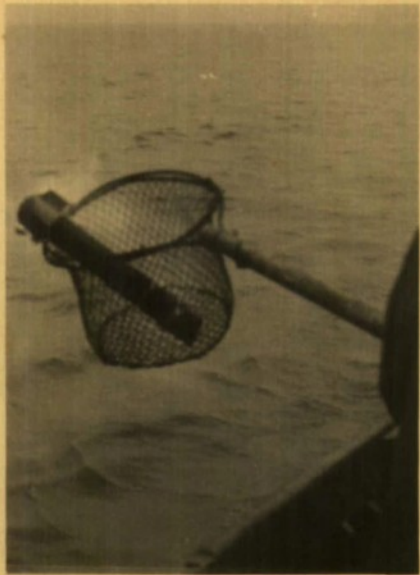
Except for the failures in Lot 1, due to faulty design and manufacture, the performance has been consistently good with no serious damage to the float.

1. No.1 - RECOVERY, BURNING COMPLETED  
NOTE ABSENCE OF DAMAGE TO FLOAT
